Grays Harbor County Satsop River Bridge

Spokane County Old I-90 Over Spokane River

City of Tacoma Puyallup River Bridge

Whakiakum County Grays River-Durrah Bridge

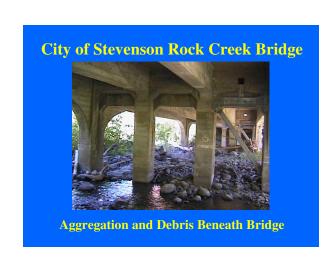
Scouring Around Pier Bedrock
